Carlton Street Footbridge - Update April 2021 Page 1 v1

Carlton Street Footbridge – Update May 2021 Page 1 v2

Carlton Street Footbridge Update – Sept. 2021 Page 1 v4

Carlton Street Footbridge – Update Feb. 2023 Page 1 v7

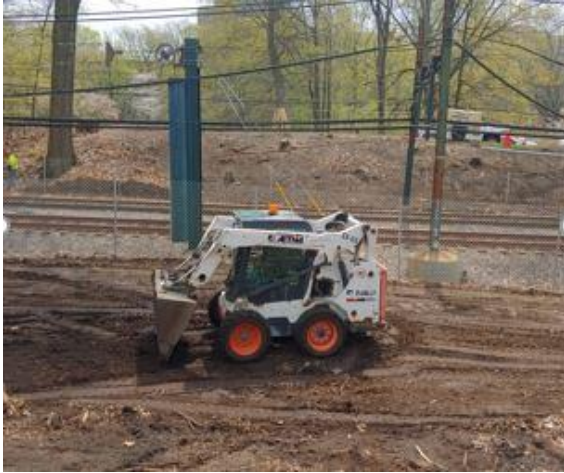
Trees and brush have been cleared on north side for access by heavy equipment

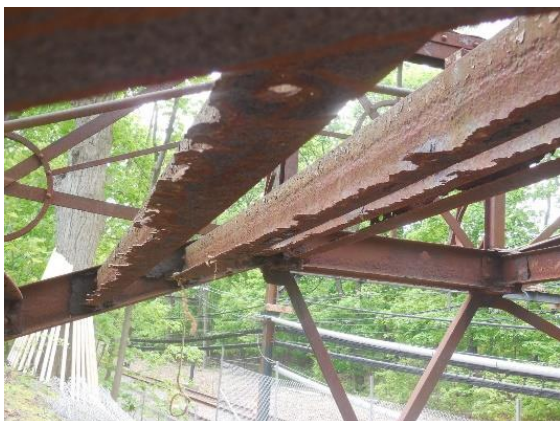
Rusted treads will be removed and replaced with new treads

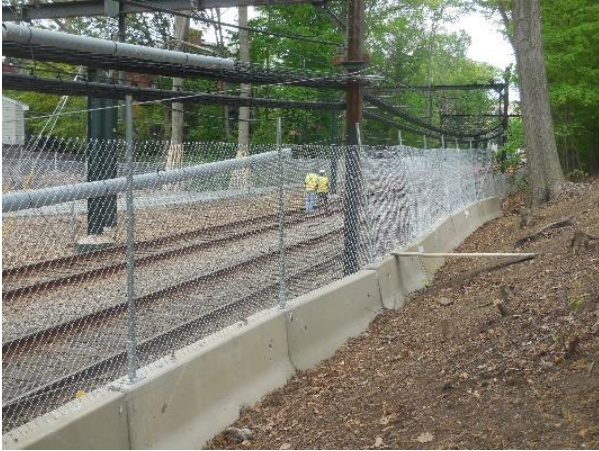
MBTA fencing along D line right-of-way (ROW) has been replaced with concrete barrier topped with chain link fence

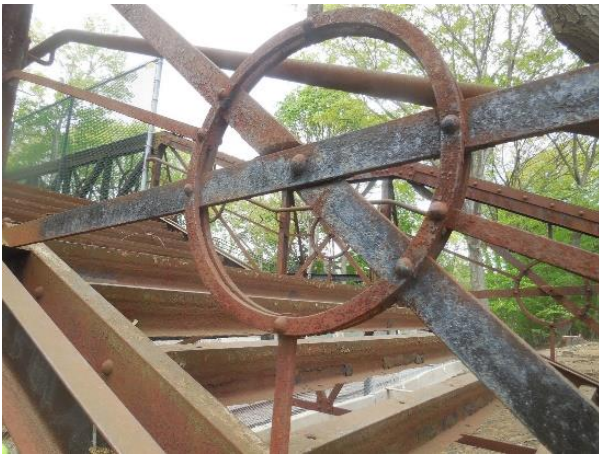
Decorative ironwork will be restored

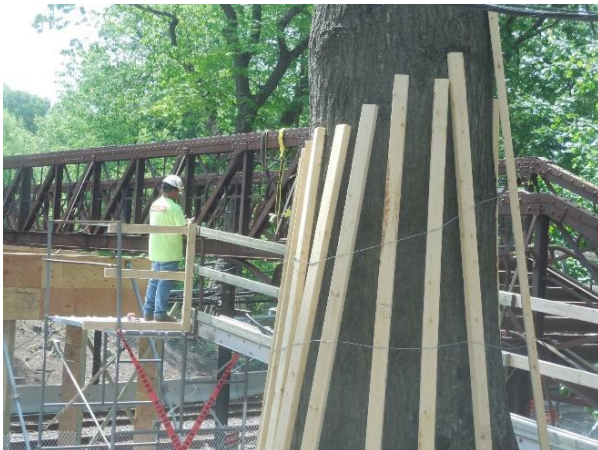
Worker replaces rusted rivets with bolts which can be easily removed when bridge is dismantled.

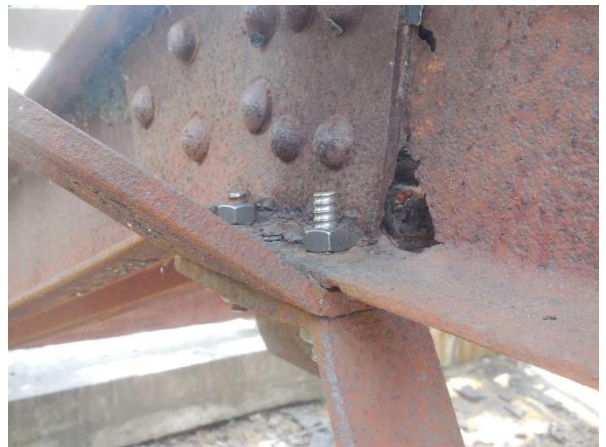
Heads of rusted rivets are removed with a pneumatic rivet buster using a chisel bit and punch bit. Bolts can be easily removed when bridge is dismantled.

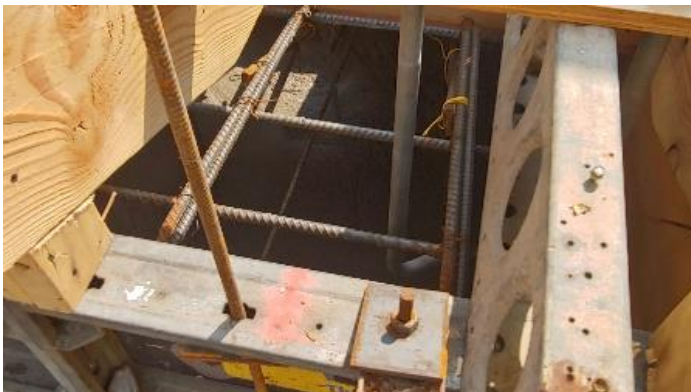
Rebar (reinforcing bar) is used to increase the tensile strength of the concrete, helping to resist cracking and breaking.

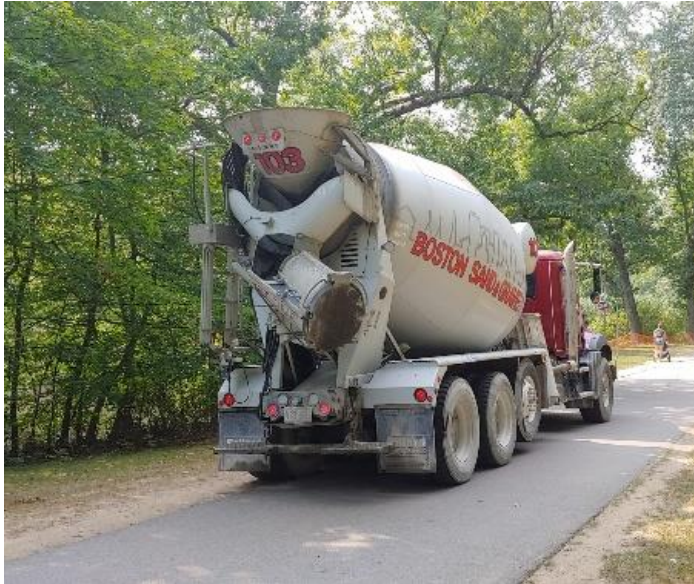
The first of 3 trucks arrives with 10 cubic yards of cement for the park side steps.

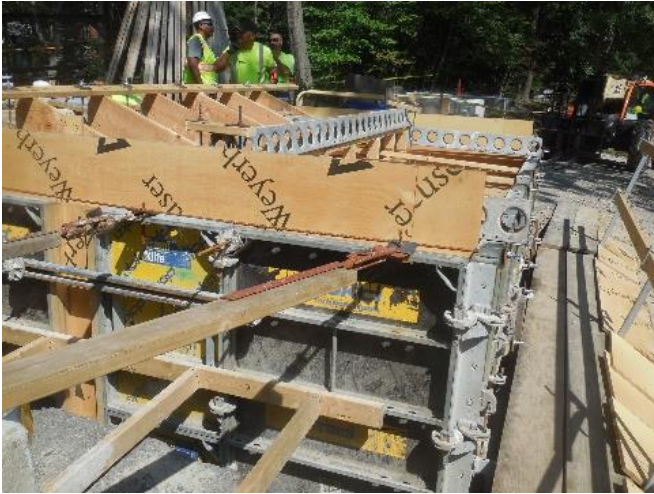
“Doka” steel concrete forms will be removed in about a week, exposing the finished 13-foot wide stairway..

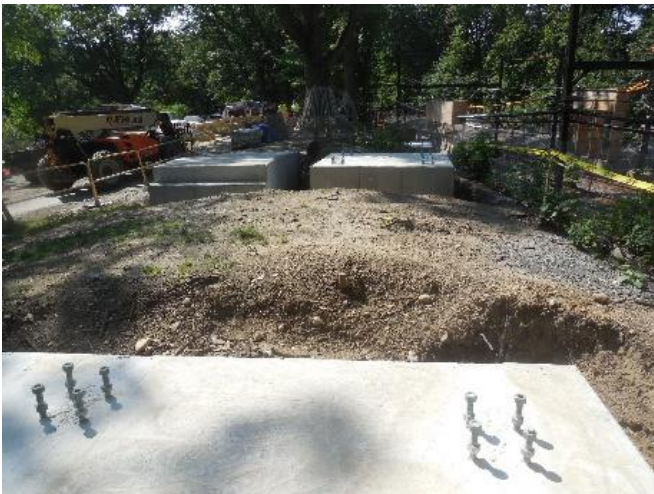
Extensive ramps will be supported by concrete forms which have already been constructed on the park side.

Work on concrete stairways, and a series of concrete bases using 310 cubic yards of cement is practically complete. These will support over 200 feet of metal ramps, creating a fully accessible entry to Riverway Park.

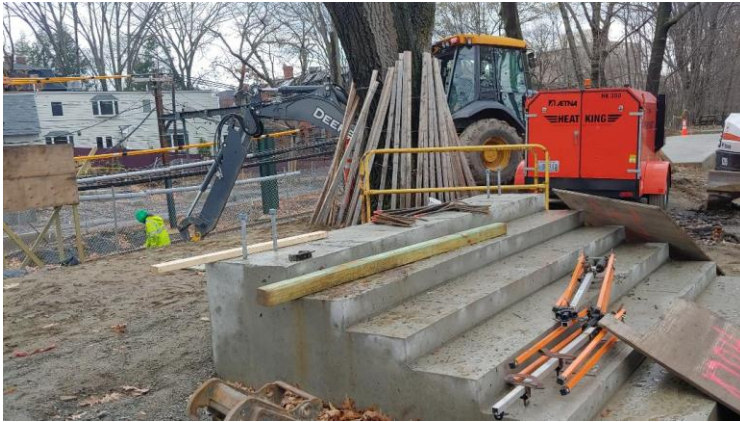
Work on site for the winter will be paused. In Rhode Island, the steel main and stairway trusses will be welded and sandblasted over the winter.

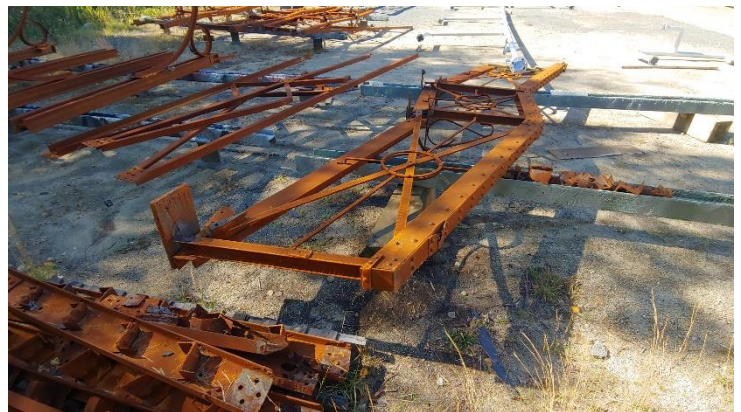
In Coventry, RI the steel trusses await restoration.

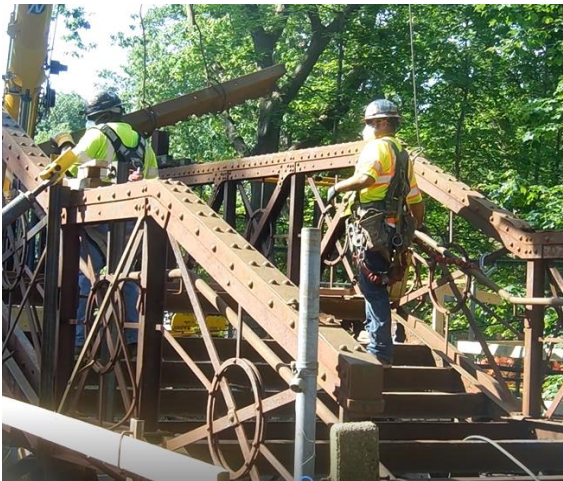
Sparks flying, stair treads are cut out by Aetna welders. Treads will be replaced with durable wood decking

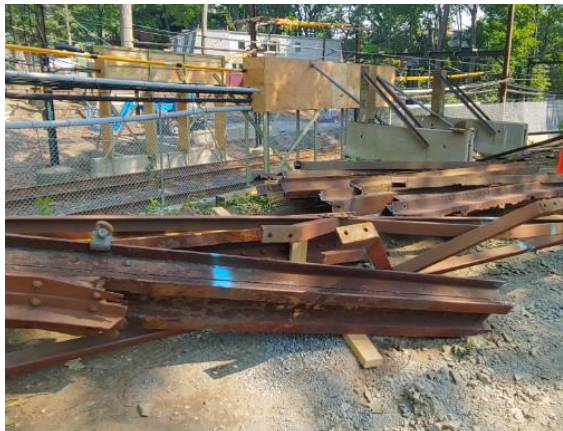
Rusted treads will be scrapped

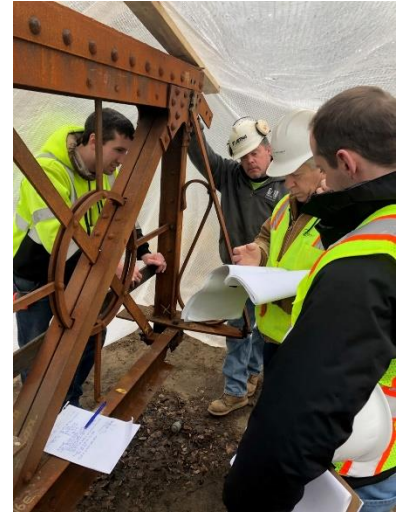
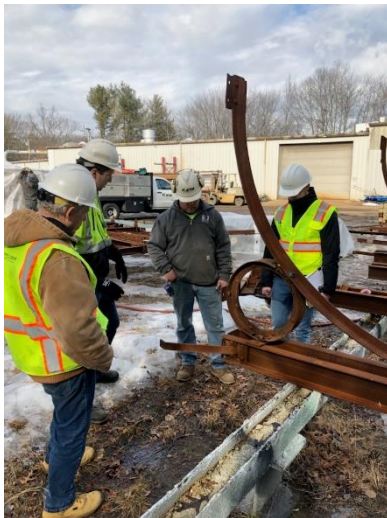
In Coventry RI , truss restoration has been underway throughout the winter. Here, consultants review the welded bonds which will then be independently ultrasonically tested.

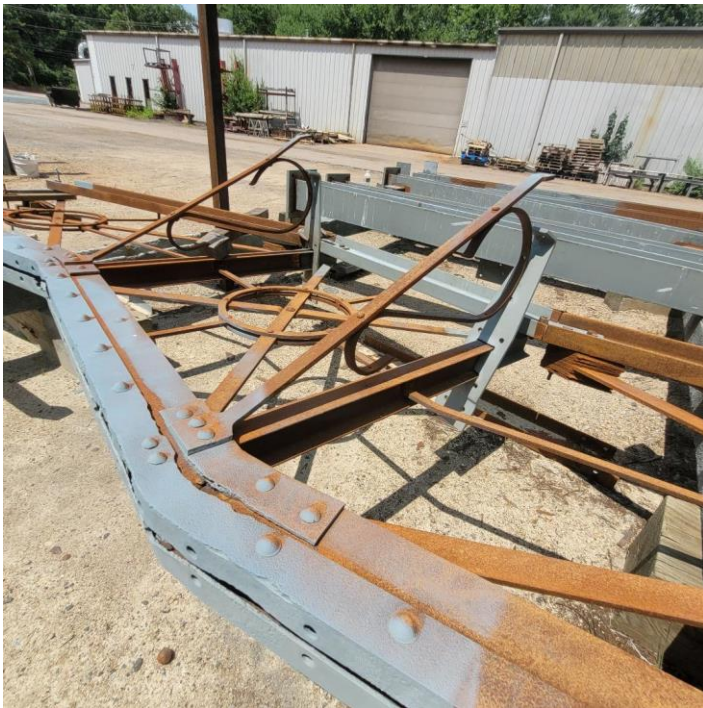
In Coventry, welding of main truss and stairways continues.

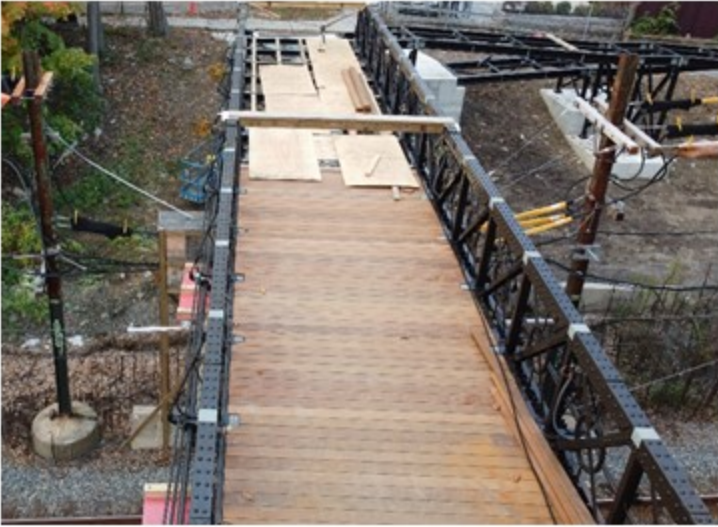
Well, everything did fit – finally. Two days later, the wooden decking is almost complete – just in time for the end of the week-long pause in MBTA service.

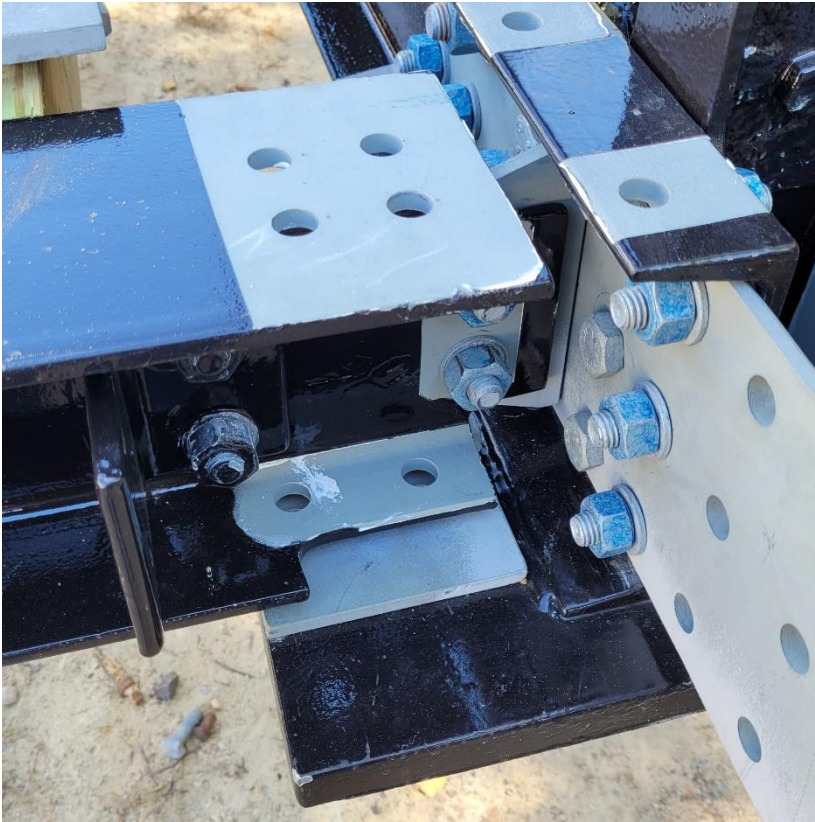
Reconstruction is complex. In Coventry RI, all the pieces must be labelled, welded, tested for strength, holes drilled for new $\frac{3}{4}$ " galvanized bolts, sandblasted to remove rust, primed, coated with an epoxy paint, and a coat of urethane added for weather resistance.

Then it all has to fit when installed on site in Brookline.

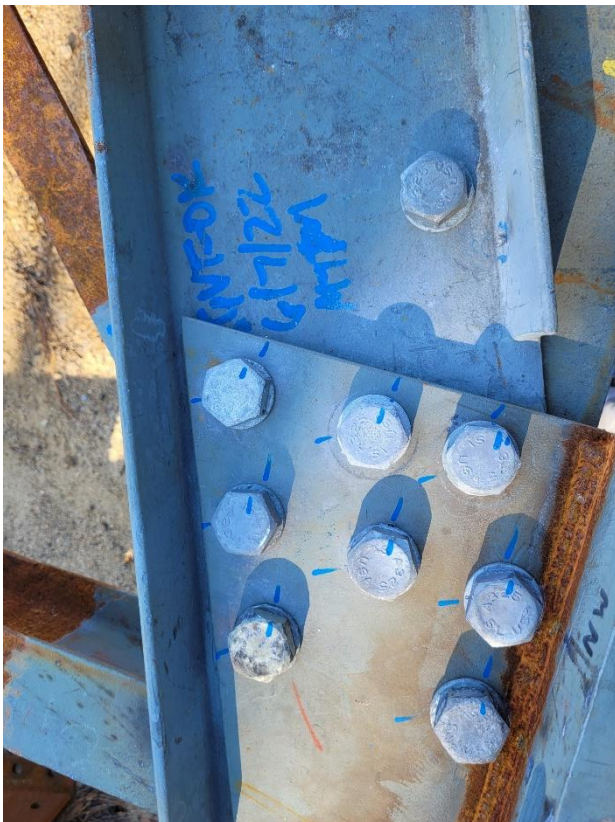
Bolts must be installed and "torque tested", indicated here by the blue lines on the bolt heads.

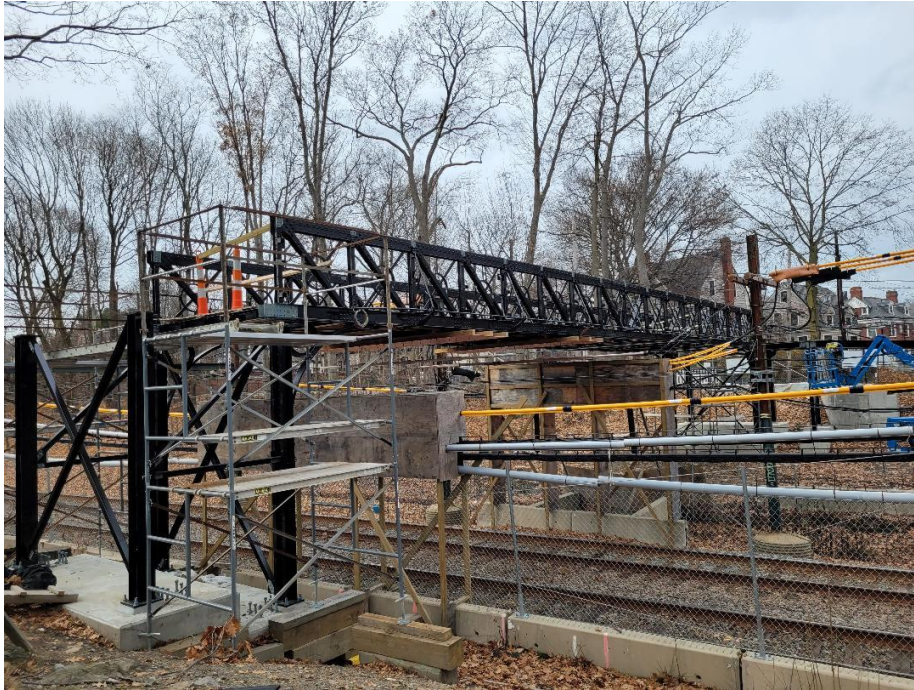
Main span in position awaiting installation of ramps and stairways. This restoration is about 2' higher to meet MBTA requirements. The bridge has been lengthened to accommodate the insertion of 6'-wide ADA ramps on each end.

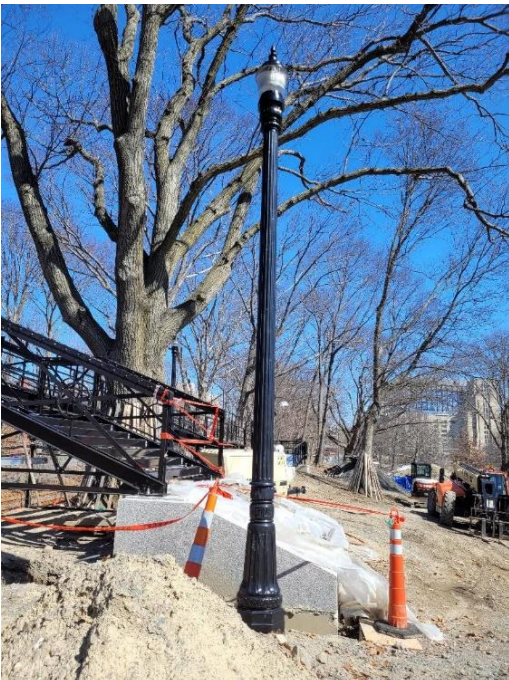
A 13' cast aluminum Acorn Light Pole (Bostonian style) with polyester powder-coat gloss black finish has just been installed.

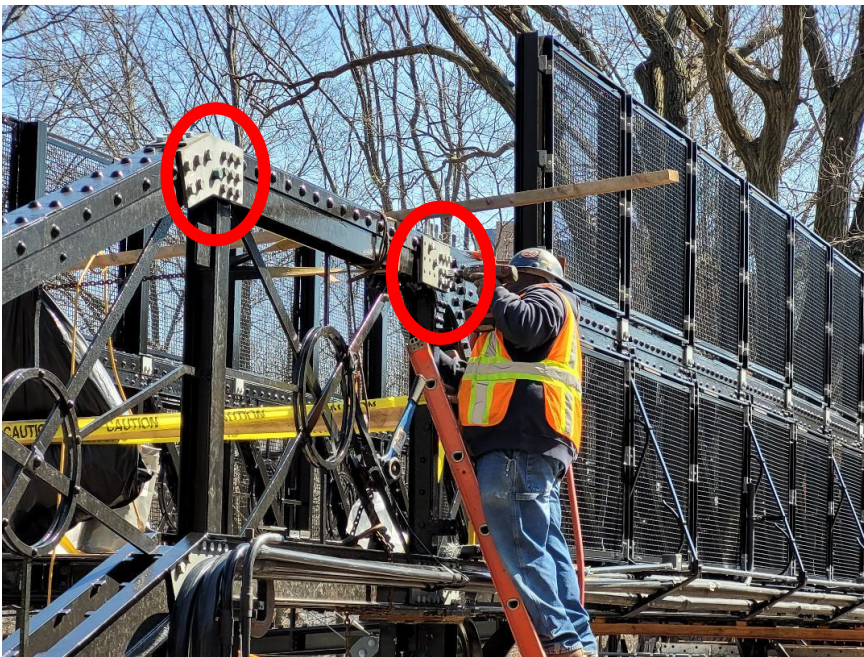
Truss repair gusset plates - are used to connect beams and columns together. Here, bolts are being tightened to strengthen connections.

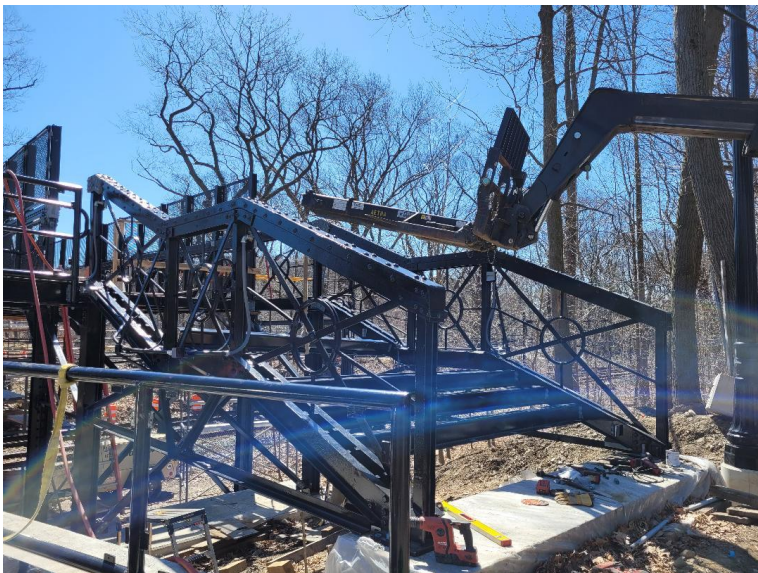
Early in April, the north (street-side) stairway arrived from Coventry, RI, now strengthened with new welds, sandblasted, primed and painted anew, was lifted and bolted into place by Aetna Bridge ironworkers.

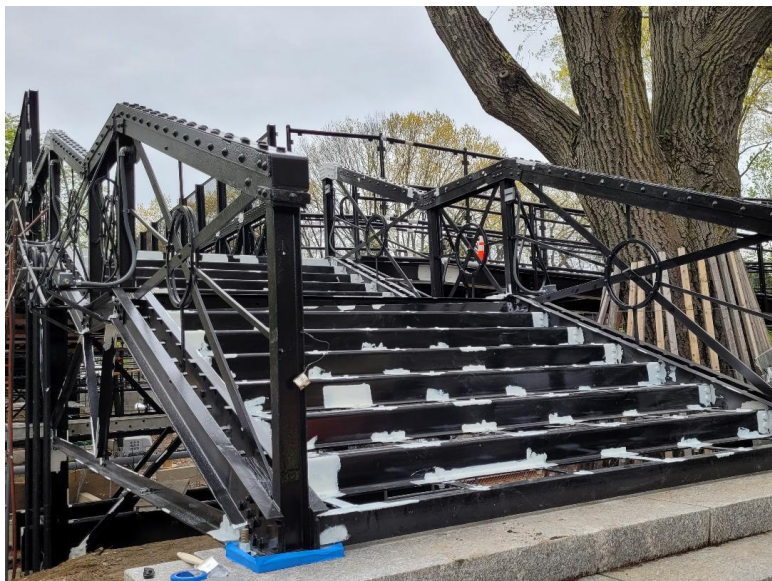
Final touchup of paint starts with a 2-part epoxy primer. The final coat, also a 2-part epoxy, is then applied.

In 2010, samples were removed from north side stairway surfaces that had been protected from weathering. These were analyzed microscopically to match the original paint.

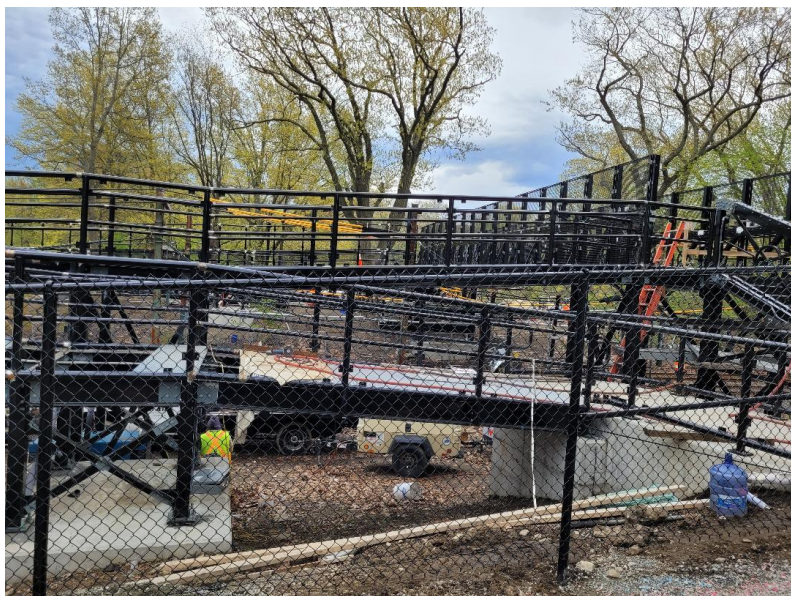
120' of 6'-wide ramp is installed on the park (south) side and 91' on the street (north) side. Railings are welded and primed before final painting.

A total of over 1,600 square feet of aluminum grating is used for the ramps.

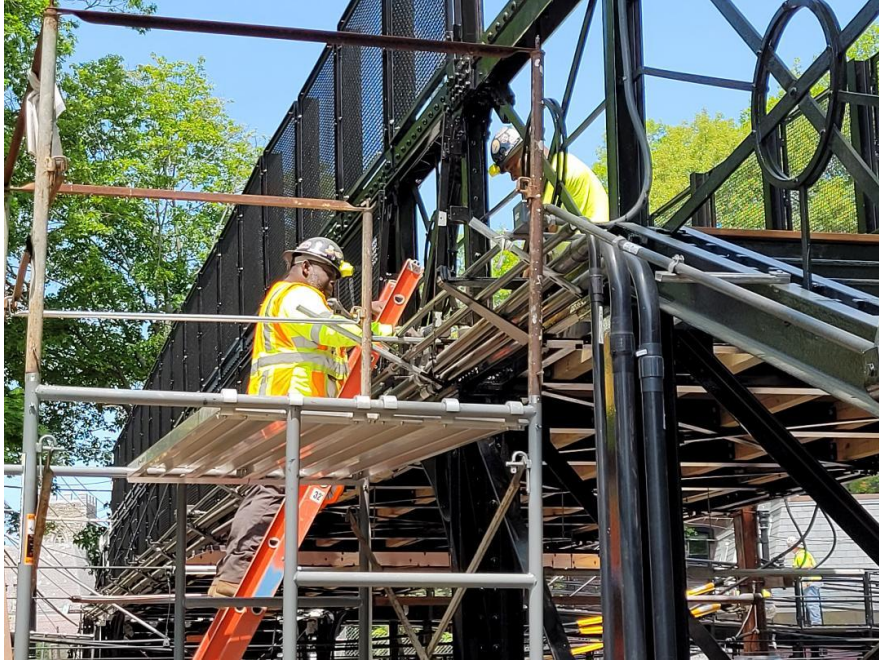
An Aetna worker installs conduit for the electric line that will power the light fixture and police call box in the park.

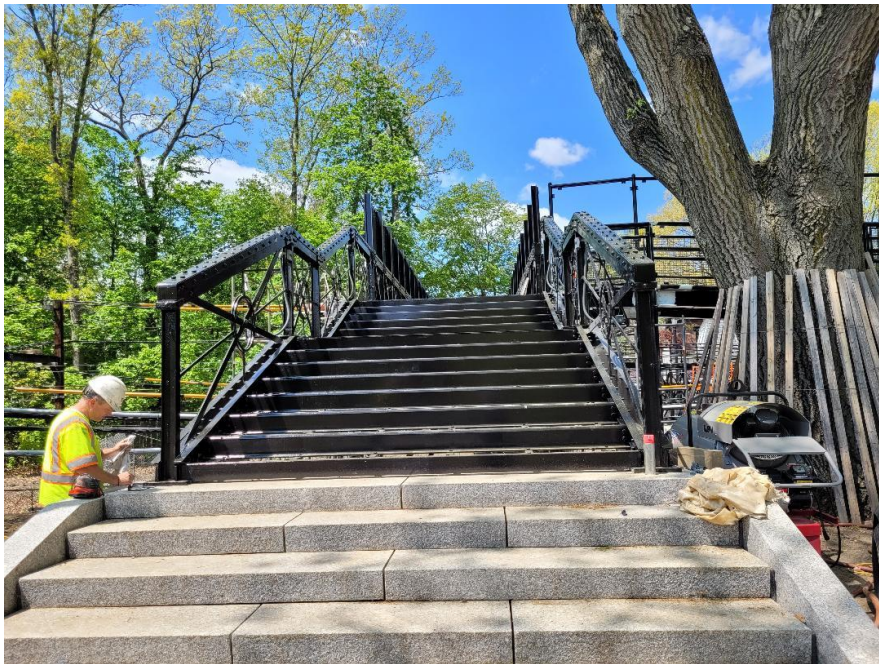
Granite steps lead to the restored stairway. Grout will be applied to all the seams to guard against moisture.

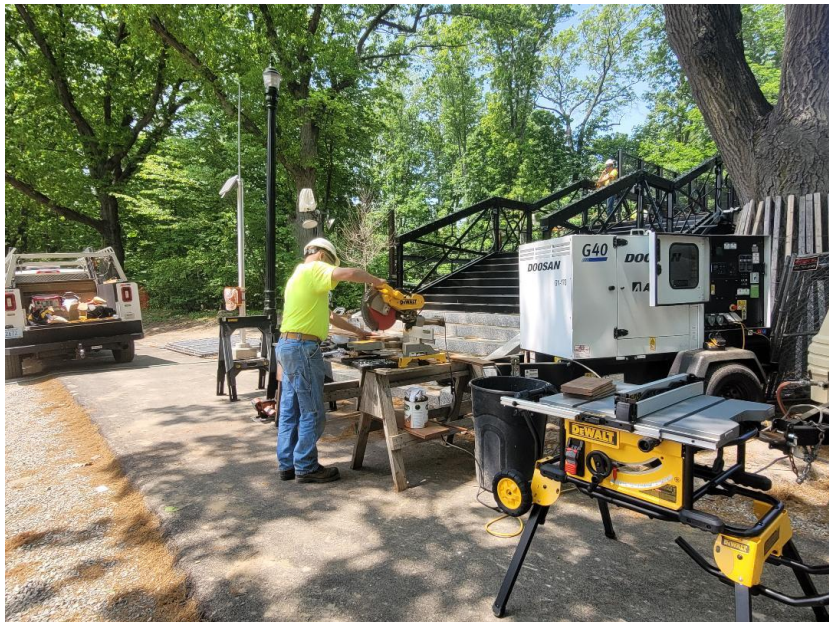
An Aetna carpenter starts to cut the board for the decking, tread and risers.

These are being constructed using ipe, (pronounced epy), a teak-like Brazilian hardwood known for its durability and insect resistance.

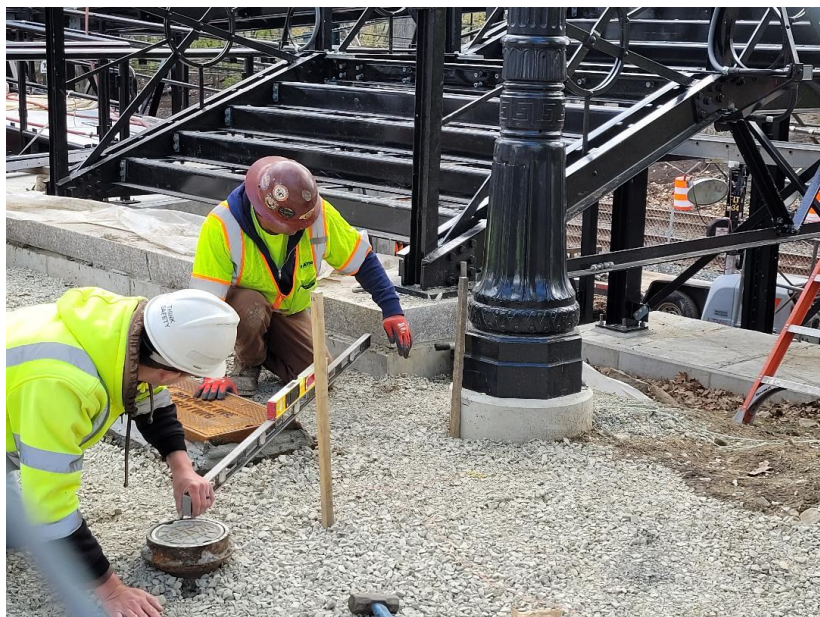
“Measure twice, cut once”. On the Carlton Street side, the concrete pavement must slope to allow proper drainage and prevent ice.

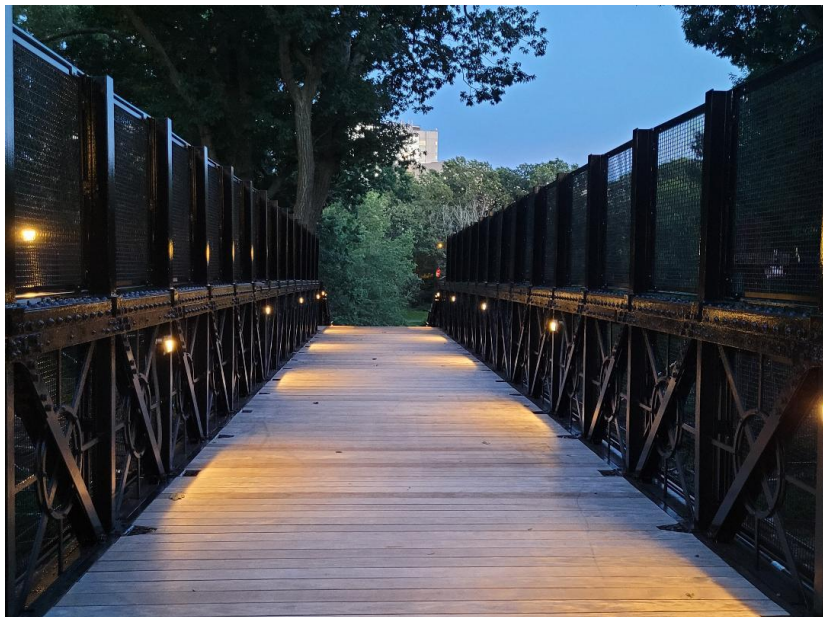
LED lights, set to turn on in the fading light, cast a warm glow over the wooden decking.
